# AN UNUSUAL FIFTEENTH-CENTURY BUILDING WITH A SPECIAL FIRST-FLOOR ‘MEETING ROOM’ – 15 KNIGHTRIDER STREET, MAIDSTONE

DAVID AND BARBARA MARTIN

*The account which follows describes the location of the building and summarizes the in-depth phase-by-phase archaeological interpretative survey undertaken in 2002 and revised in 2003.<sup>1</sup>*

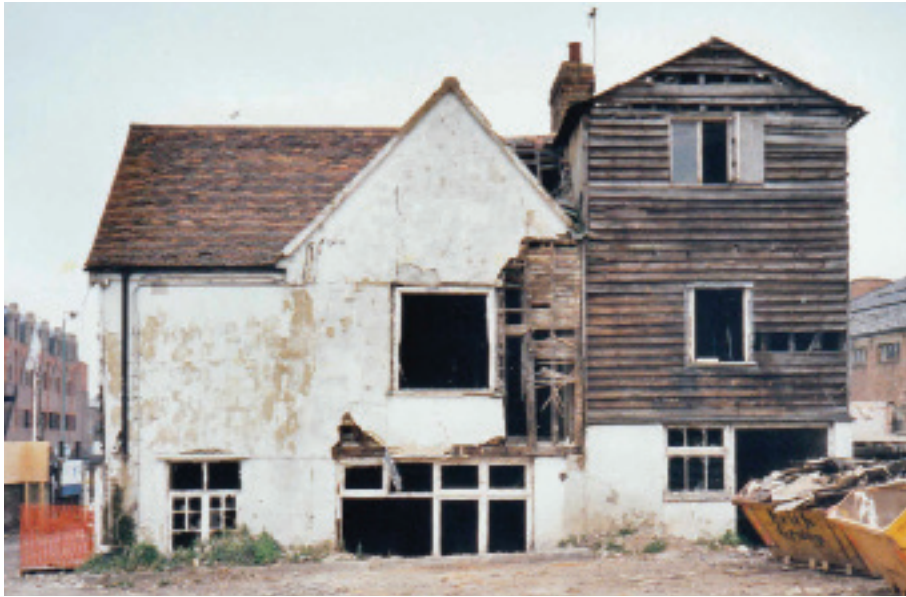
PLATE I

Exterior from the south showing the Phase-2 main range with added ranges to left and right.

No. 15 Knightrider Street was first inspected by the authors in June 2002 with a view to assessing its age, form, and subsequent development up to the present day. At that time the building was standing unused and was in poor repair (**Plates I and II**). Most of the windows were boarded up and many of the rooms, particularly those on the ground floor, contained large quantities of rubbish, making access difficult. Little historic fabric was visible below roof level, the vast majority being masked by nineteenth-century plaster coverings. The data as available in 2002

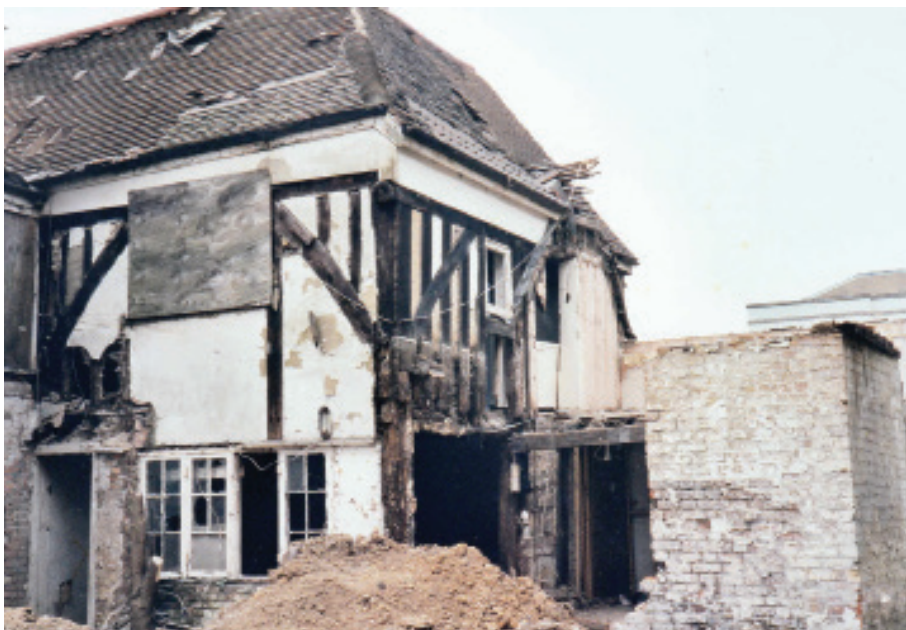
PLATE II

South-eastern corner of Phase-3 kitchen range with remains of later added range on right.

The kitchen structure is sturdily framed and incorporates close studding within all its external walls. Unlike within the *Phase-2* part (where the braces triangulating the frame pass to the rear of the close studding) here the braces interrupt the close studding (Plate II): even so, as in the main range the close studs were intended to be visible in the external face of the wall only. The only *Phase-3* doorway which is evidenced was on the ground floor at the extreme southern end of the ‘kitchen’ range’s western wall. As with the *Phase-2* doorways, the opening was originally fitted with an arched head. A chamfer is evidenced running around the surround, with a second order of chamfering extending up the principal post and, originally, around the lower leading edge of the arched head. Square mortices in the soffits of the main timbers show that the range’s windows were each divided into three unglazed lights by mullions which were either moulded or chamfered. A vertical (rather than a horizontal) sliding shutter was fitted to the first-floor window in the east wall. The first floor is supported by very heavy, neatly-cut medieval joists aligned north-south along the axis of the building, being lodged over the crossbeam in the southern wall and jointed into the crossbeam which divides the floored part of the range from the northern smoke bay. This chamfered crossbeam has beneath its ends two small curved brackets. The roof makes use of simple paired-rafter-and-collar construction, absent of crownposts.

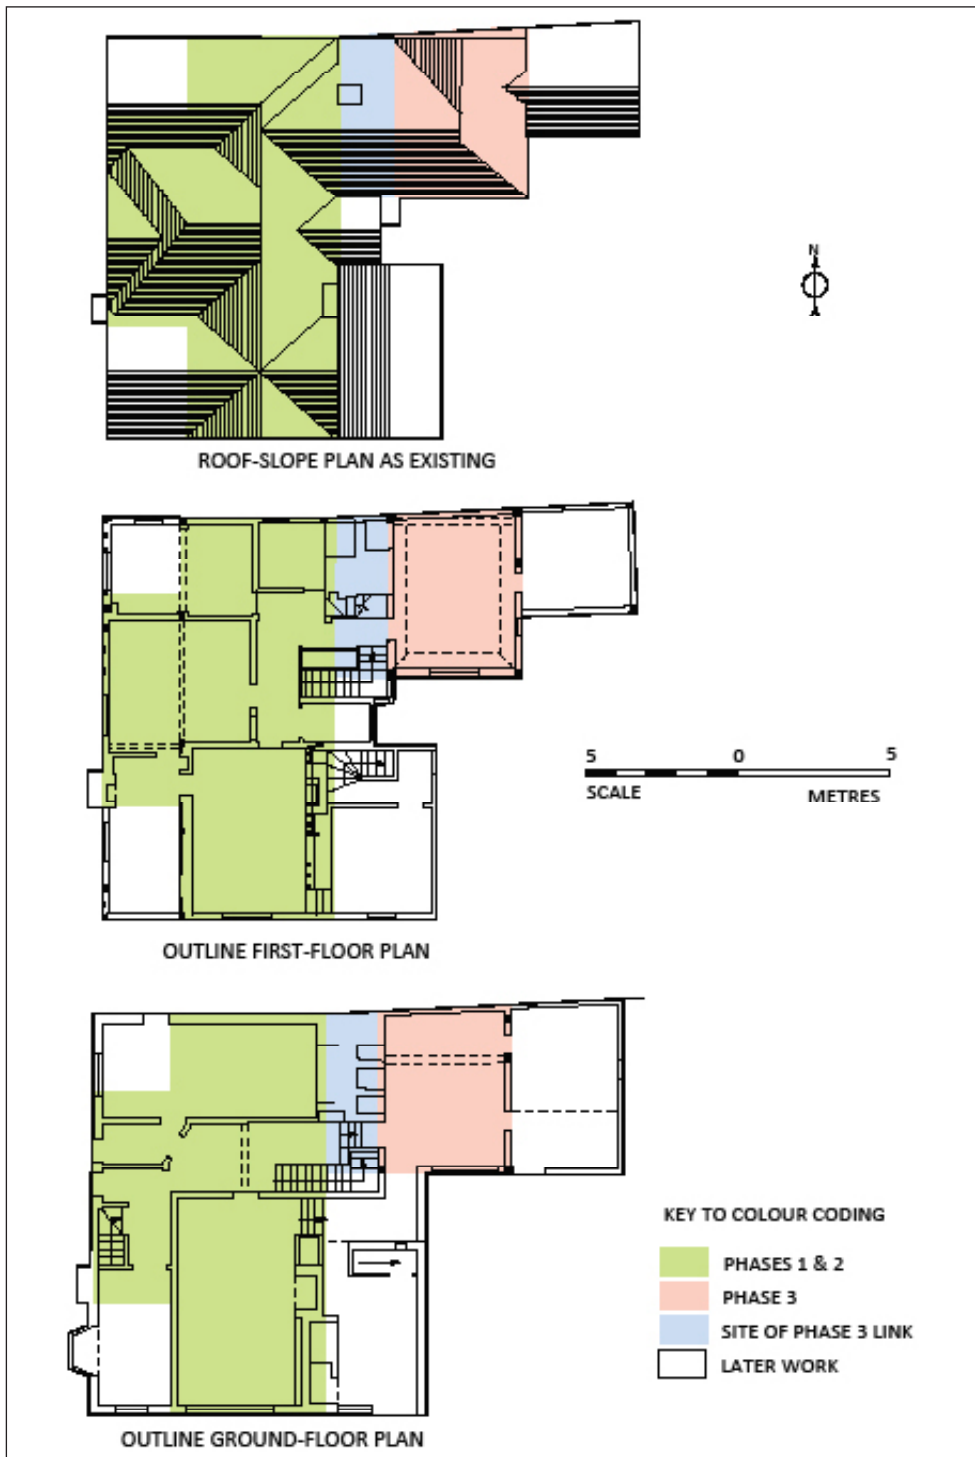
Fig. 3 Plans as existing in 2003 showing sequence of development of site.

This work identified up to eight distinct phases in the development of no. 15, the first four of which – covering the fifteenth and sixteenth centuries – are described in detail below (**Fig. 3**).
