THE COMPLEX OF ROMAN BUILDINGS EXCAVATED BY MAAG AT EAST FARLEIGH, 2005-17: AN INTERIM REPORT

STEPHEN CLIFTON

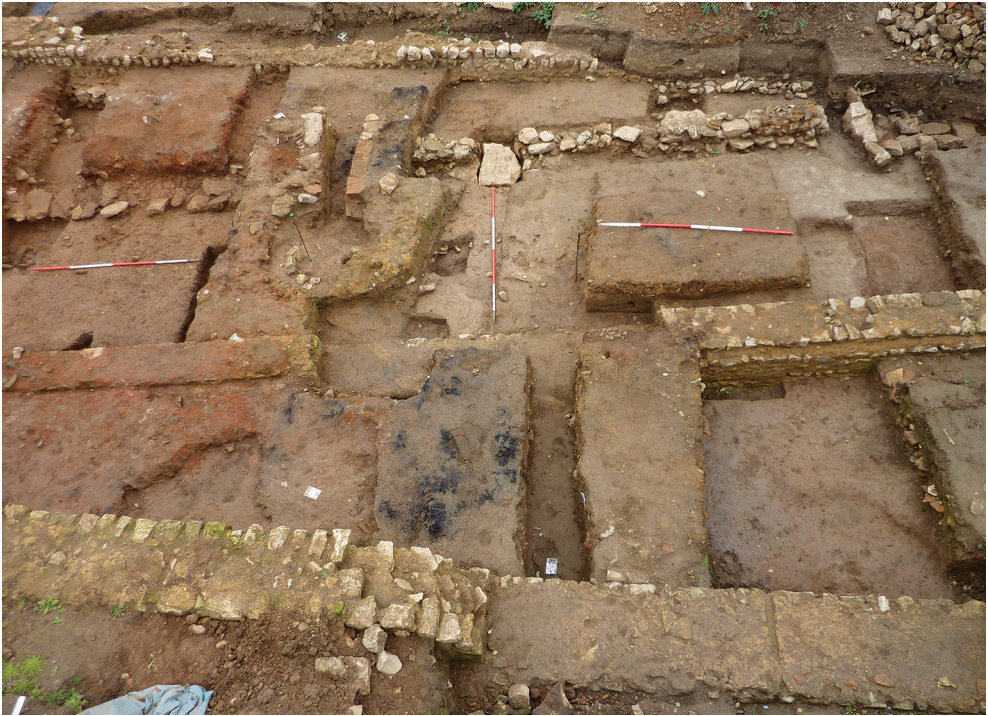
Fig. 6 The central area of Building 3 (Clifton 2011), looking north showing the reddened earth from the heat of ovens at the western end and the late corn-dryer inserted over the fill of ditch B. The southern wall and entrance to Building 2 can be seen in the centre, reduced to floor level. The southern entrance to Building 2 can be seen in bottom right.

A later phase of usage was represented by three larger ‘corn-dryer’ type ovens which were inserted into the building, cutting through the reddened floor surface, and although these yielded no dating evidence, they must have been introduced late in the building’s life, probably in the fourth or fifth centuries. When excavated, a large capping stone was found placed on top of one of the structures. This stone showed no sign of the effects of heat or indeed any usage, and so the conclusion must be drawn that this was a ritual act at the cessation of its useful life, a phenomenon seen elsewhere on the site.

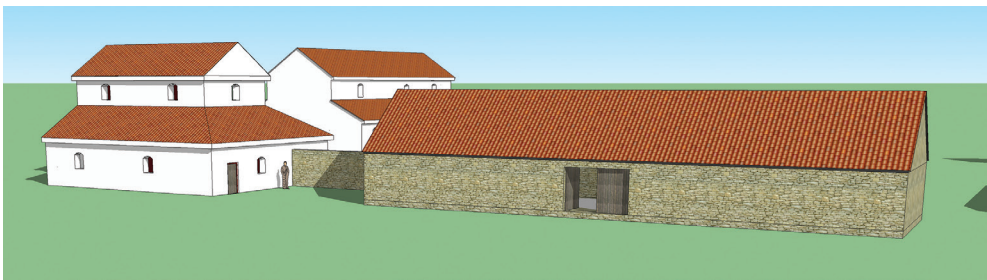
Fig. 9 Buildings 3 and 5 seen from the south (Clifton 2020).

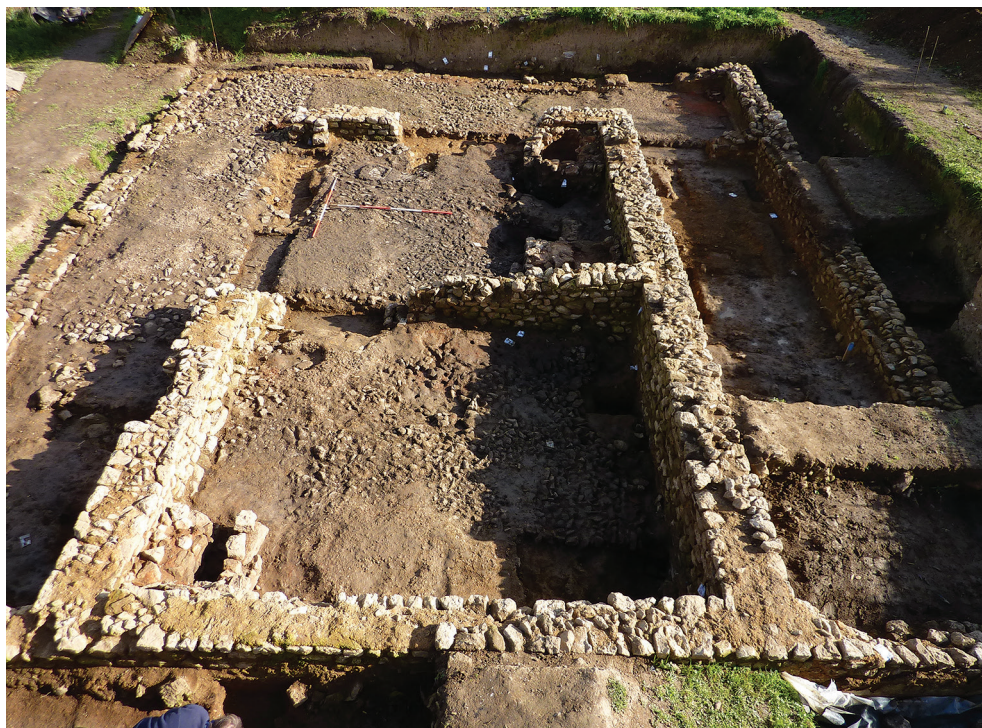
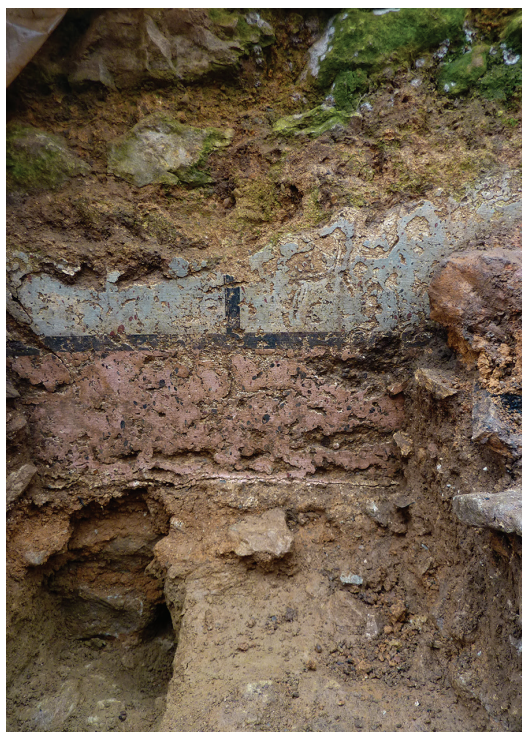
Fig. 10 (above) Building 5 seen from the west and (right) painted plaster on external wall (Clifton 2010).

Britain there was some painted wall plaster remaining on the *external* western wall comprising black banding separating a lower red section and an upper white/pale blue section (Fig. 10). This plasterwork did not appear to extend around the corners to the adjacent walls. There was also evidence for painted plaster on the internal walls although none remained attached. This plasterwork was painted a deep ‘Pompeian’ red, except for areas at the western end of the northern corridor and the southern section where it was painted white. There were no indications of any

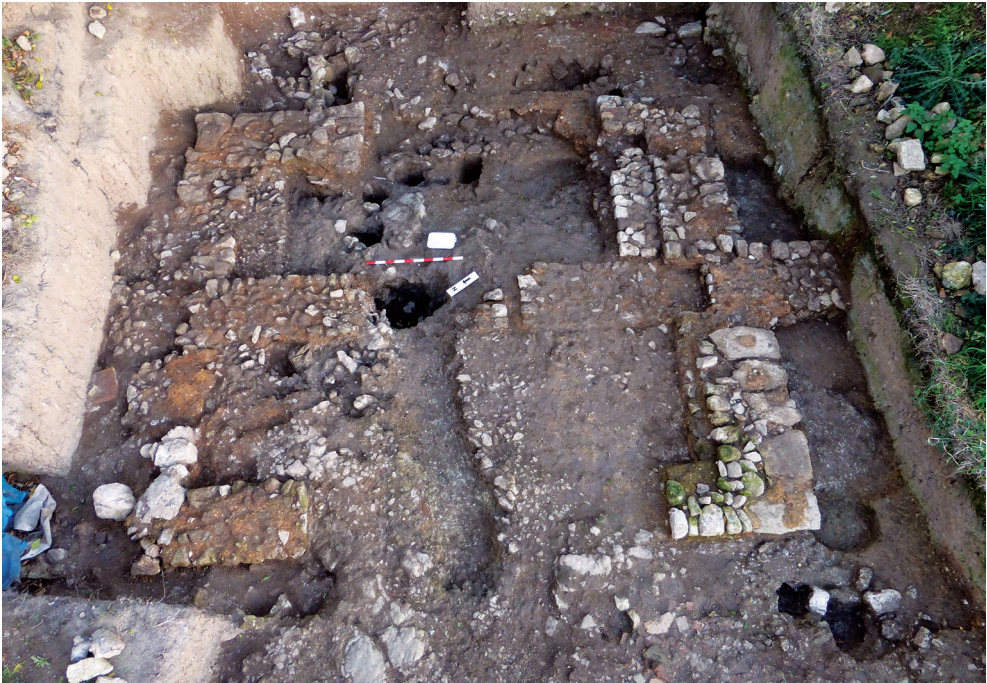
Fig. 12 Building 6 (Clifton 2017).

The building measures roughly 5.0 x 5.5m. The most striking thing about it is that there is a wall (0.88m wide), running through the middle of the building from south-west to north-east. This central wall had been demolished down to close to floor level within the building, effectively forming two 'C' shaped sections bisected by this central wall. There was no doorway between the two halves visible, although there was a small channel, 0.12m wide, that appeared to have been built into the structure, possibly to allow drainage from one chamber to the other.

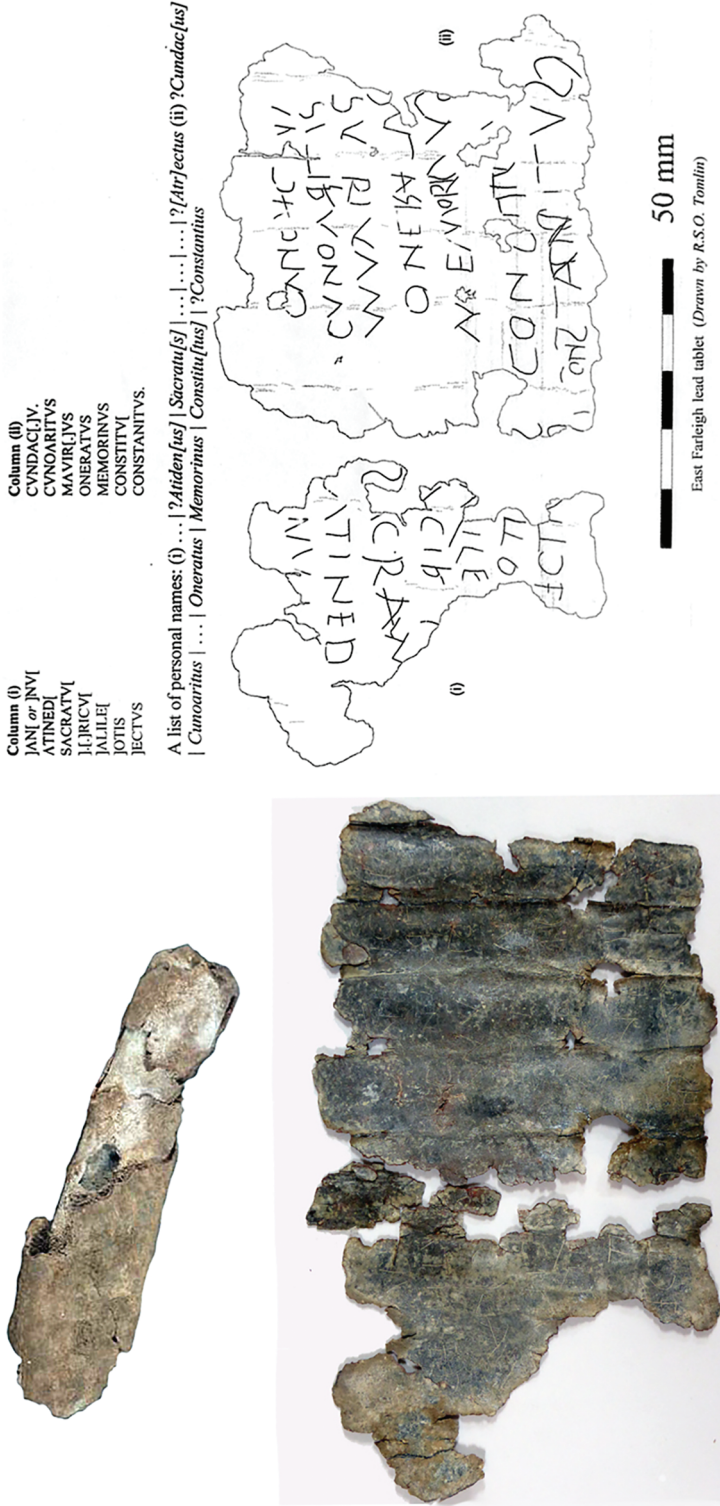
Fig. 13 *Defixio* found at East Farleigh (illustration from R.S.O. Tomlin 2016).

The assemblage of finds at East Farleigh has many parallels with other sacred sites and is equally unremarkable in not providing a pointer towards a particular deity or ritual activity. Although there is one building believed to be a temple, there are several other buildings which could also have been shrines dedicated to other gods. The nature of the sacred beliefs and the identity of the particular deity have often been the subject of speculation based on the ‘votive’ objects. However, it may just be that people merely used whatever they owned that looked like a valuable object, irrespective of the nature of the deity. It is also suggested that items could be purchased at the temple for just this purpose. The ‘hoard’, found in the sub-floor layer of the *cella* of Building 5 consisted almost entirely of coins that were clipped; this is very common at cult sites and perhaps points to their preparation specifically for votive activity (Woodward 1992, 67). There were also a number of pieces of copper and lead sheet, which were uninscribed in any way, but which would most likely have been shiny when deposited. There is no indication of any sort of shop or kiosk amongst the buildings excavated so far, however there are similarities in the rings and bracelets found, which might indicate a common source produced at or near the complex. The lead *defixio* found at East Farleigh contains a list of 14 names (**Fig. 13**), some using ‘mirror writing’ to add extra potency but alas gives no further clue to the circumstances of its deposition or the deity invoked (Tomlin 2016, 415).

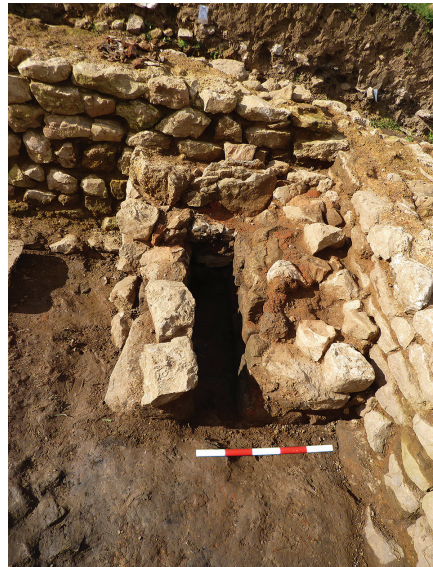
Fig. 14 Building 5: (a) outer cella room showing various oven structures; (b) showing oven built into corner of the inner cella room. (Clifton 2010).

Then there are the other oven-like structures built into the fabric of Building 5 (**Fig. 14**). There may have been others elsewhere on the site, but they have not survived. The two inside the building, both constructed of mortared stone and built into a corner, are very different to each other. The larger of the two (the ‘bread-oven’) in the outer chamber was clearly contemporary with the construction of the building, as evidenced by the offsetting of the doors through to the inner chamber, if the doors had been central, they would have fouled the oven and it would have been too hot and cramped. It is conceivable that the structure was not originally intended as an oven; an alternative interpretation as the base for a lead tank or cult statue is possible. Any daub superstructure and plasterwork has disappeared, so it

is impossible to say for sure, but the presence of reddened clay and stone within the circular structure makes its use as a hearth or oven seem likely, at least periodically. The other oven structure in the inner chamber is rectangular and much smaller and was found choked up with red and black ash and soot. The obvious question is why there are two such structures within the building, albeit of different proportions, which clearly had different functions.
